Winding Failures of Electrical Motors

If an electric motor is subject to improper operating conditions, either electrical, mechanical or environmental, the winding life will be significantly reduced.

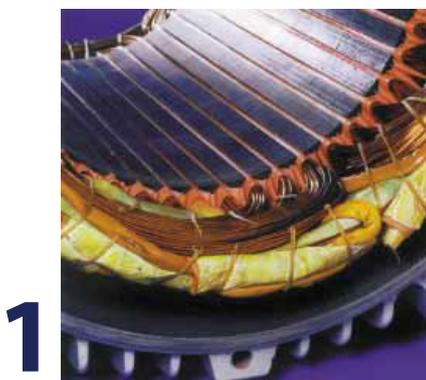
**WINDING SHORTED
TURN-TO-TURN**

Picture number 1, 2, 3, 4, 5 and 9:

These pictures show insulation defects caused by contaminants, abrasion or voltage fluctuation.

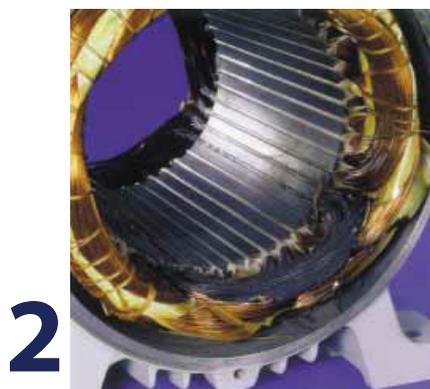
**WINDING WITH
SHORTED COIL**

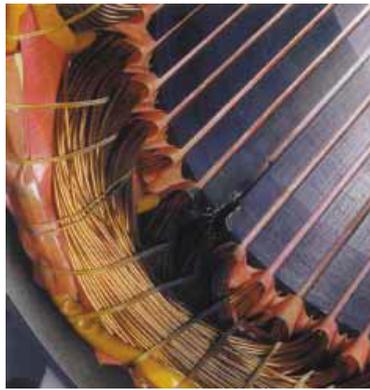
3

**WINDING GROUNDED
AT THE EDGE OF SLOT**

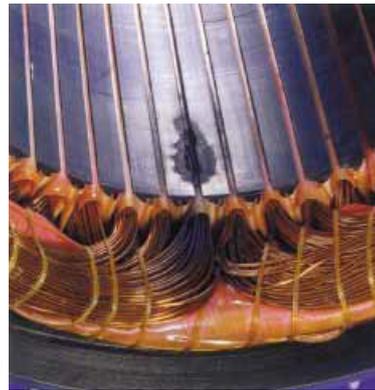
4

**WINDING GROUNDED
AT THE SLOT**

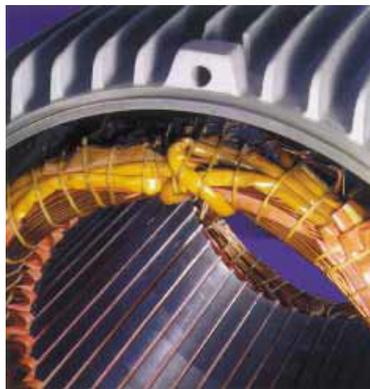
5

**SHORTED
CONNECTION**

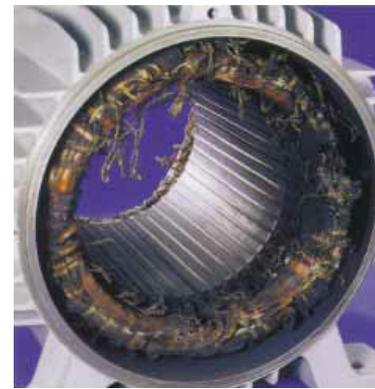
6

**WINDING DAMAGED
DUE TO OVERLOAD**

Picture number 6:

The complete insulation burning out on all phases of the three-phase winding is caused by motor overload. Under or overvoltages cause the same type of failure.

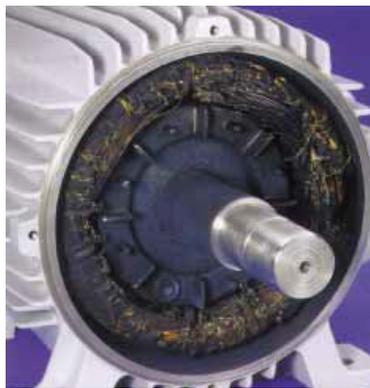
7

**DAMAGE CAUSED BY
LOCKED ROTOR**

Picture number 7:

The complete insulation burn out on all phases is normally caused by high currents in the stator winding due to locked rotor. This can also occur due to excessive starts and reversions.

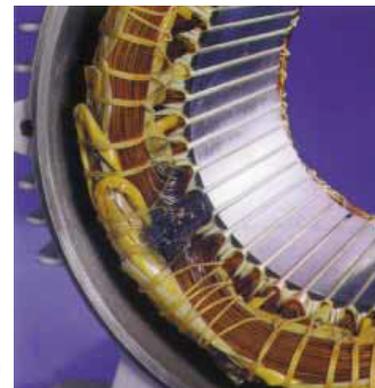
8

**WINDING DAMAGED
BY VOLTAGE SURGE**

Picture number 8:

Insulation defects such as this are normally caused by voltage peaks that often occur in the power circuit commutation, atmospheric discharge, semi-conductors power devices and capacitor discharge.

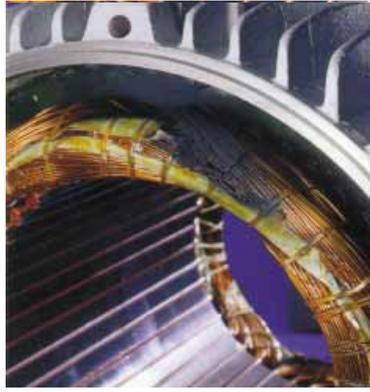
9

**WINDING SHORTED
PHASE-TO-PHASE**

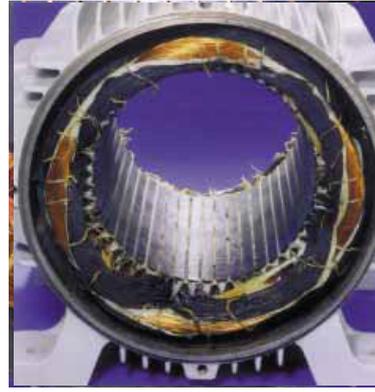
**WINDING SINGLE
PHASED (Y-connected)**

Pictures number 10 and 11:

The winding single-phase defect is a consequence of an interruption in one power supply phase. This defect is normally caused by a burnt fuse, open contactor, one power supply interrupted or poor connection.

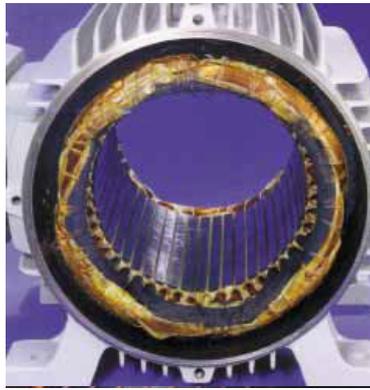
11

**WINDING
SINGLE PHASED
(Δ -connected)**

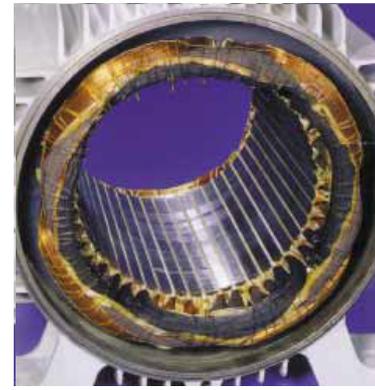
12

**PHASE DAMAGE DUE
TO UNBALANCED
SUPPLY VOLTAGE**

Picture number 12:

The insulation burn out in one phase of the stator winding can be a result of uneven voltage between phases. Uneven voltages are usually caused by unbalanced loads in the power supply originated by poor connections at motor terminals or by bad contact. 1% of voltage unbalance can cause a current unbalance from 6% to 10%.

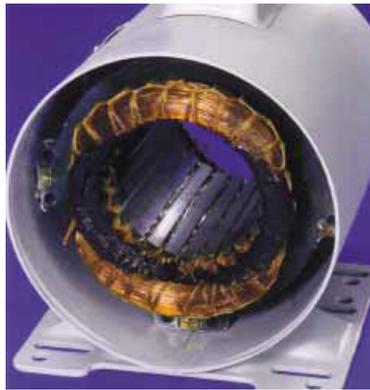
13

DAMAGED

Picture number 13:

The auxiliary coil or starting burn out is normally caused by the non-opening of the centrifugal and stationary switch set where this coil remains switched on longer than the specified time. Foreign bodies that might penetrate into the motor can cause this defect.

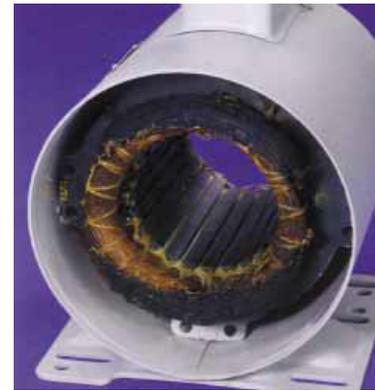
14

Picture number 14:

An overload causes a complete insulation burnout of the single-phase winding main coil. Undervoltages, overvoltages or even when the auxiliary coil is not duly connected during the starting cause the same type of failure.
